FAST FACTS

Conveyor belt replacement

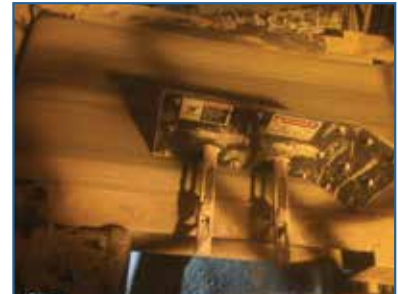
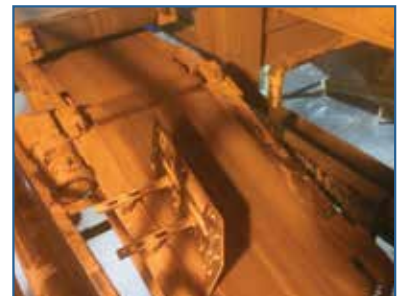
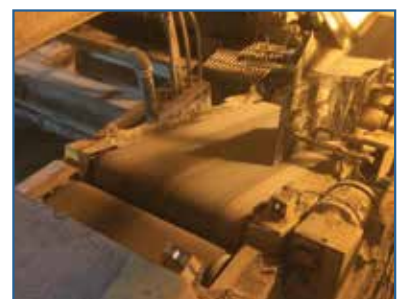
Bags traveling on a conveyor belt in the plant were being torn open when pushed by a mechanized arm. The conveyor belt was gripping the bags too firmly, causing some of them to rip upon contact with the mechanical arm.

Lewis-Goetz collaborated with another equipment manufacturer to examine the belt and determined that the incorrect belt was being used for this process. It was recommended that a longitudinal groove belt replace the rough top belt that was currently in use.

Since installation of the new belt was completed, the plant's production has increased by one pallet per hour and there are no longer any issues with bags being ripped open. By eliminating this problem and increasing production, Lewis-Goetz was able to save the customer over \$1 million annually.

**By installing a different type of belt,
Lewis-Goetz increased the plant's
production and reduced cleanup costs.**
